New York State Department of Transportation

Yellow Flag NB2228W009

BIN: 1065318

Feature Carried: 278I278IX2M23027

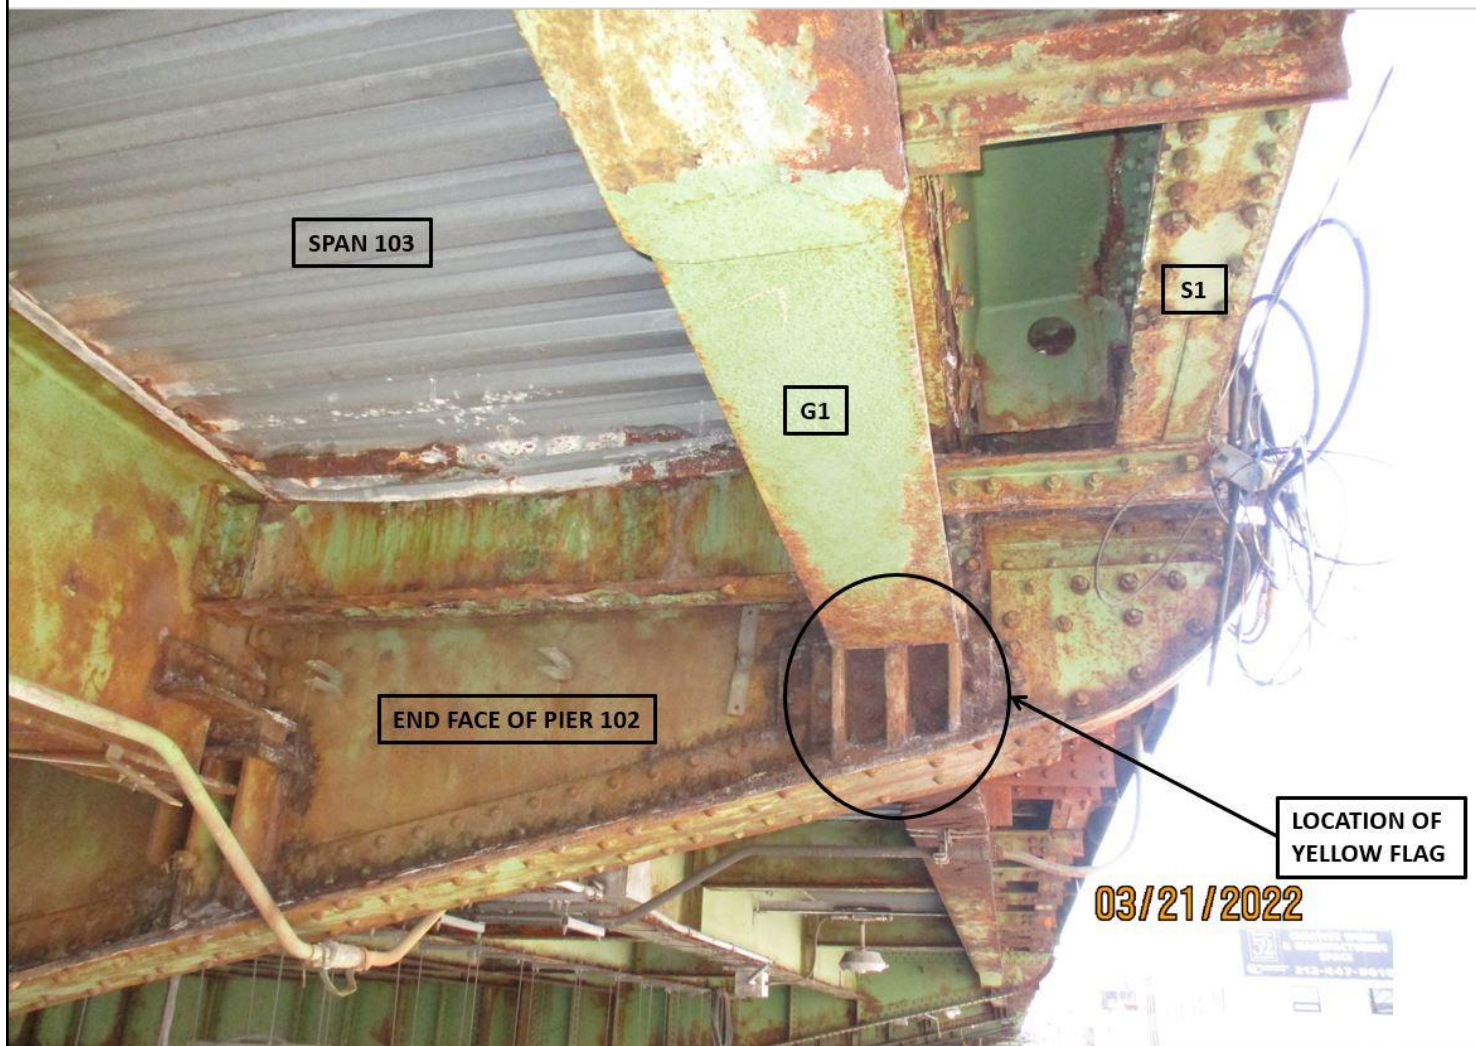
Photo Number: 1

Description: The expansion bearing under Girder G1 on Span 103 side of Pier 102 is not functioning as designed with the bearing plate now overhanging the pedestal up to 1/2". The sliding bearing plate is loose and moves when the inspection team hammers at the bearing. The bearing plate is flush with the pedestal at the left side and overhanging the pedestal for 1/2" at the right side at 55 degree F (previously noted to be overhanging the pedestal for 1" at the left side and 2" at the right side at 49 degree F) (Photos 2 and 3). The front keeper plate at the bearing exhibits 8" long broken weld at the bottom of the plate starting at the right side with the remaining 6" of the weld intact and in good condition (no change from previous inspection). Due to the movement of the bearing plate, the top of the front keeper plate is bent towards the end side for 2" (no change from the previous inspection) (Photo 4).

The bearing exhibits moderate to heavy corrosion with approximately 15% section loss.

Attachment Description: General view of the flagged condition at bearing under Girder G1 on Span 103 side of Pier 102. Looking Begin.

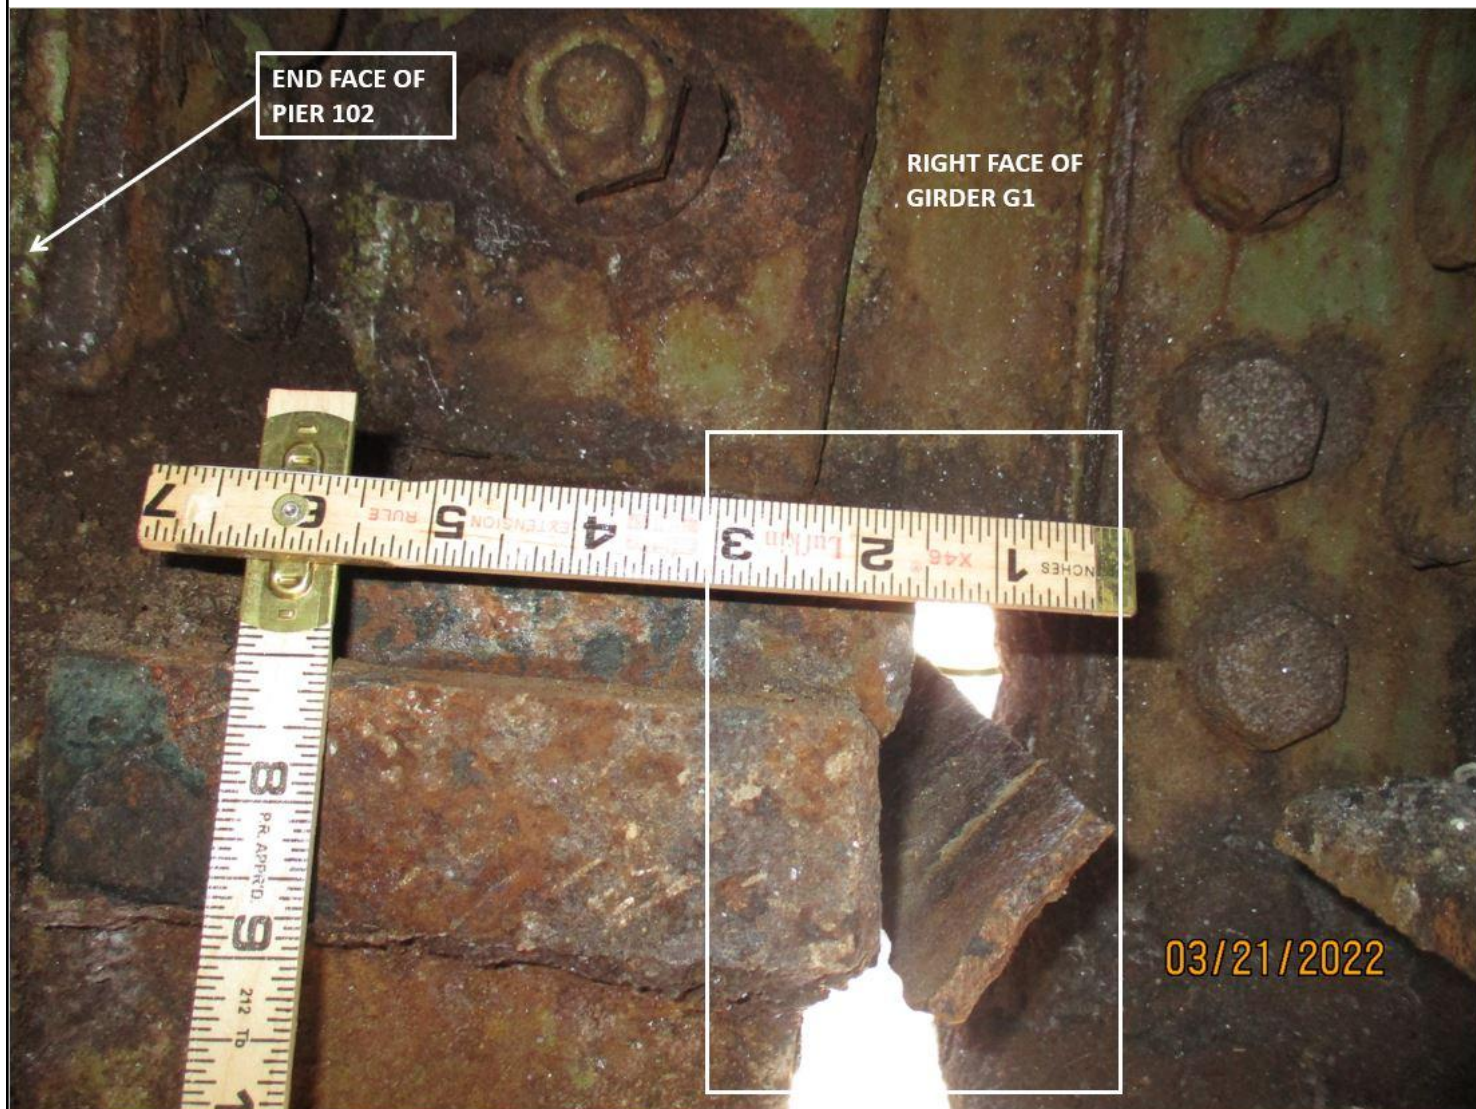
Photo Number: 2

Attachment Description: The right face of the bearing under Girder G1 on Span 103 side at Pier 102. The bearing plate is loose and overhangs the pedestal with the top of the keeper plate bent towards the end. Looking Left.

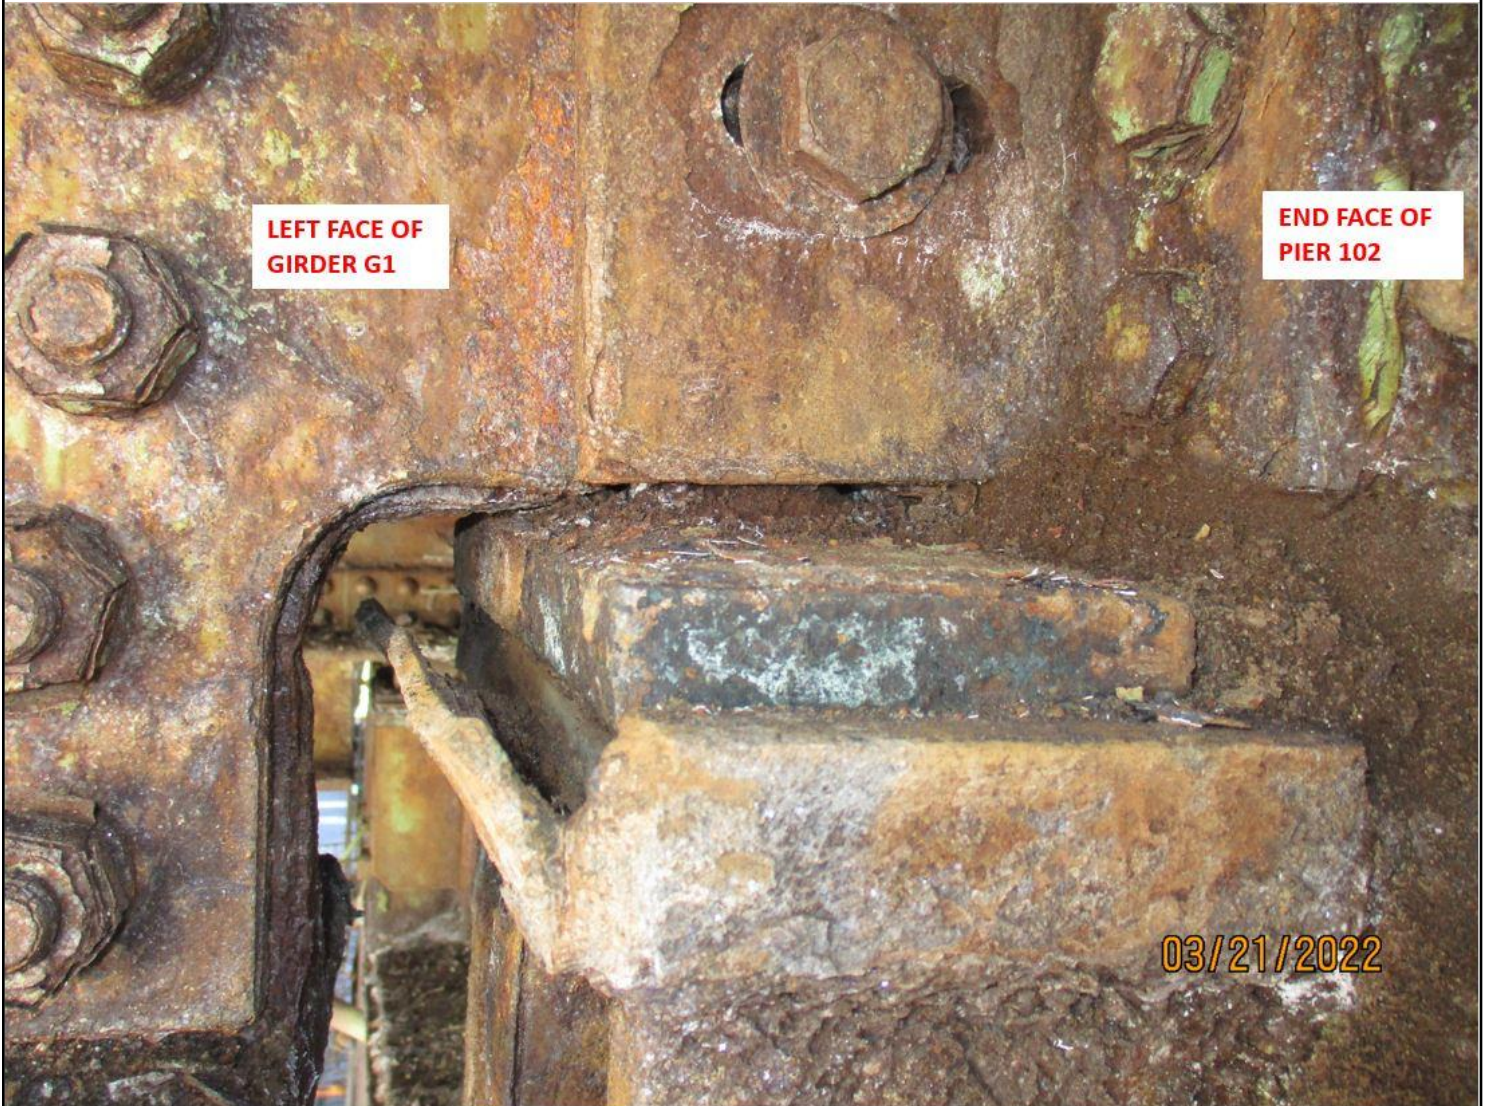
Photo Number: 3

Attachment Description: The left face of the bearing under Girder G1 on Span 103 side at Pier 102. The bearing plate is loose and is flush with the edge of the pedestal. The top of the front keeper plate is bent towards the end. Looking Right.

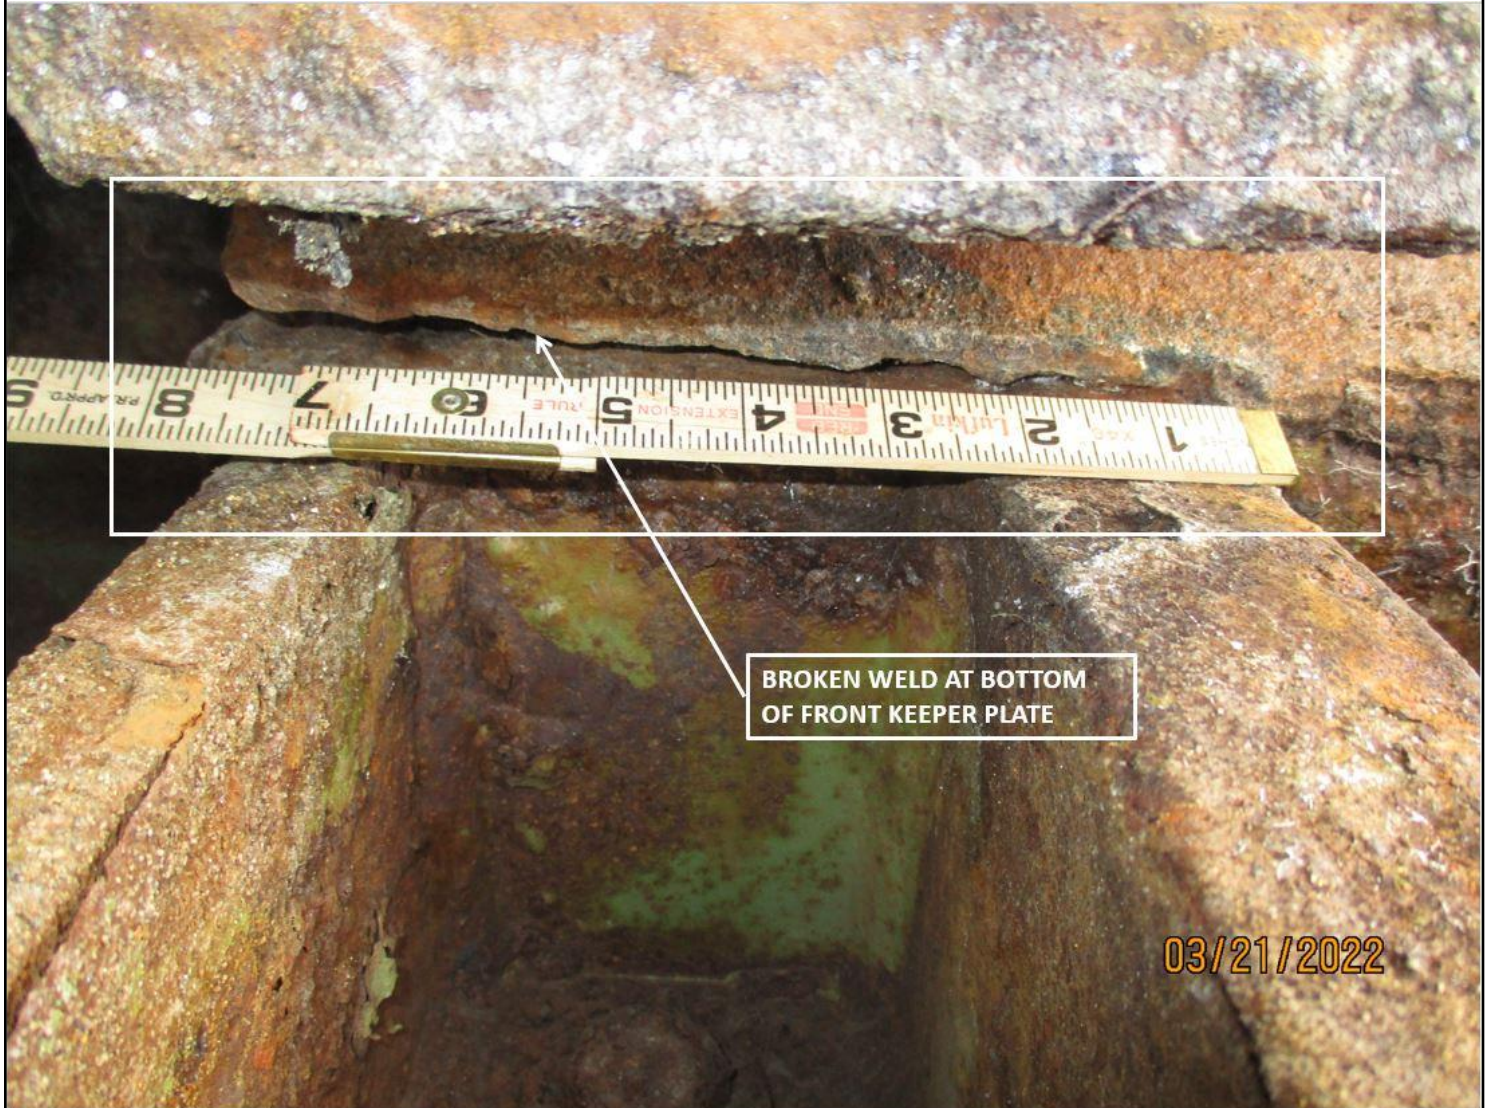
Photo Number: 4

Attachment Description: The bottom of the bearing under Girder G1 on Span 103 side at Pier 102. The bottom of the front keeper plate exhibits broken weld starting at the right side. Looking Begin.

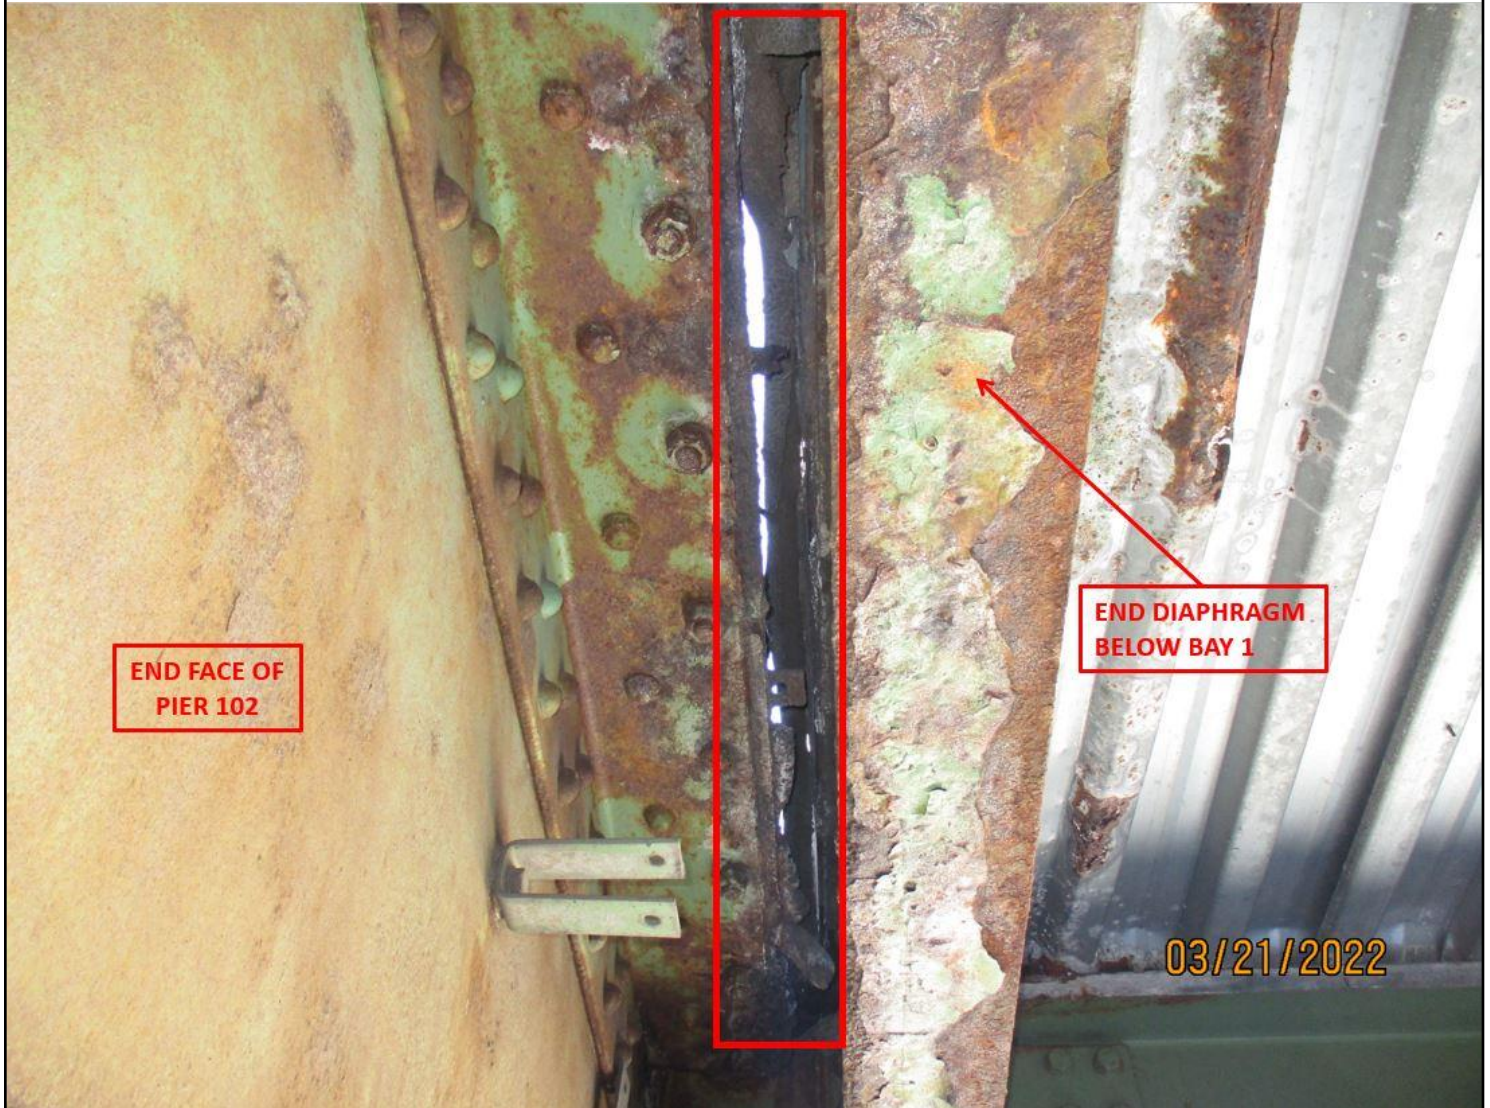
Photo Number: 5

- 1.The guide angles and keeper plates at the left and right side of the bearing exhibit corrosion but in generally good condition.
- 2.The joint seal on top of the deck is missing with daylight visible below bay 1. (Photo 5)
- 3.The end of Girder G1 at the bearing is in generally good condition.
- 4.The adjacent Girder G2 exhibits a 1" diameter corrosion hole at the top of the web adjacent to the top pre-drilled guide angle hole with 20% section loss at the lower web above the bottom flange in front of the bearing with moderate to heavy corrosion with approximately 15% section loss to the bearing plate.
- 5.The flagged condition is located above the center lane on 3rd Avenue WB roadway and was accessed using 30ft bucket truck with double left lane closure.

Attachment Description: The underside of the Pier 102 joint below Bay 1 on the end side of the pier. The joint on top of the deck exhibits missing joint seal with daylight visible from underside of joint. Looking Left.
